# CORROSION ISSUES

- Phil Sadler, Senior Utilities Safety Engineer
- Noel Travis, Utilities Safety Engineer

**SISSONVILLE, W. Va. December 11, 2012, 20-inch natural gas transmission pipeline running west to east, perpendicular to Interstate 77, ruptured about 112 feet west of Interstate 77**

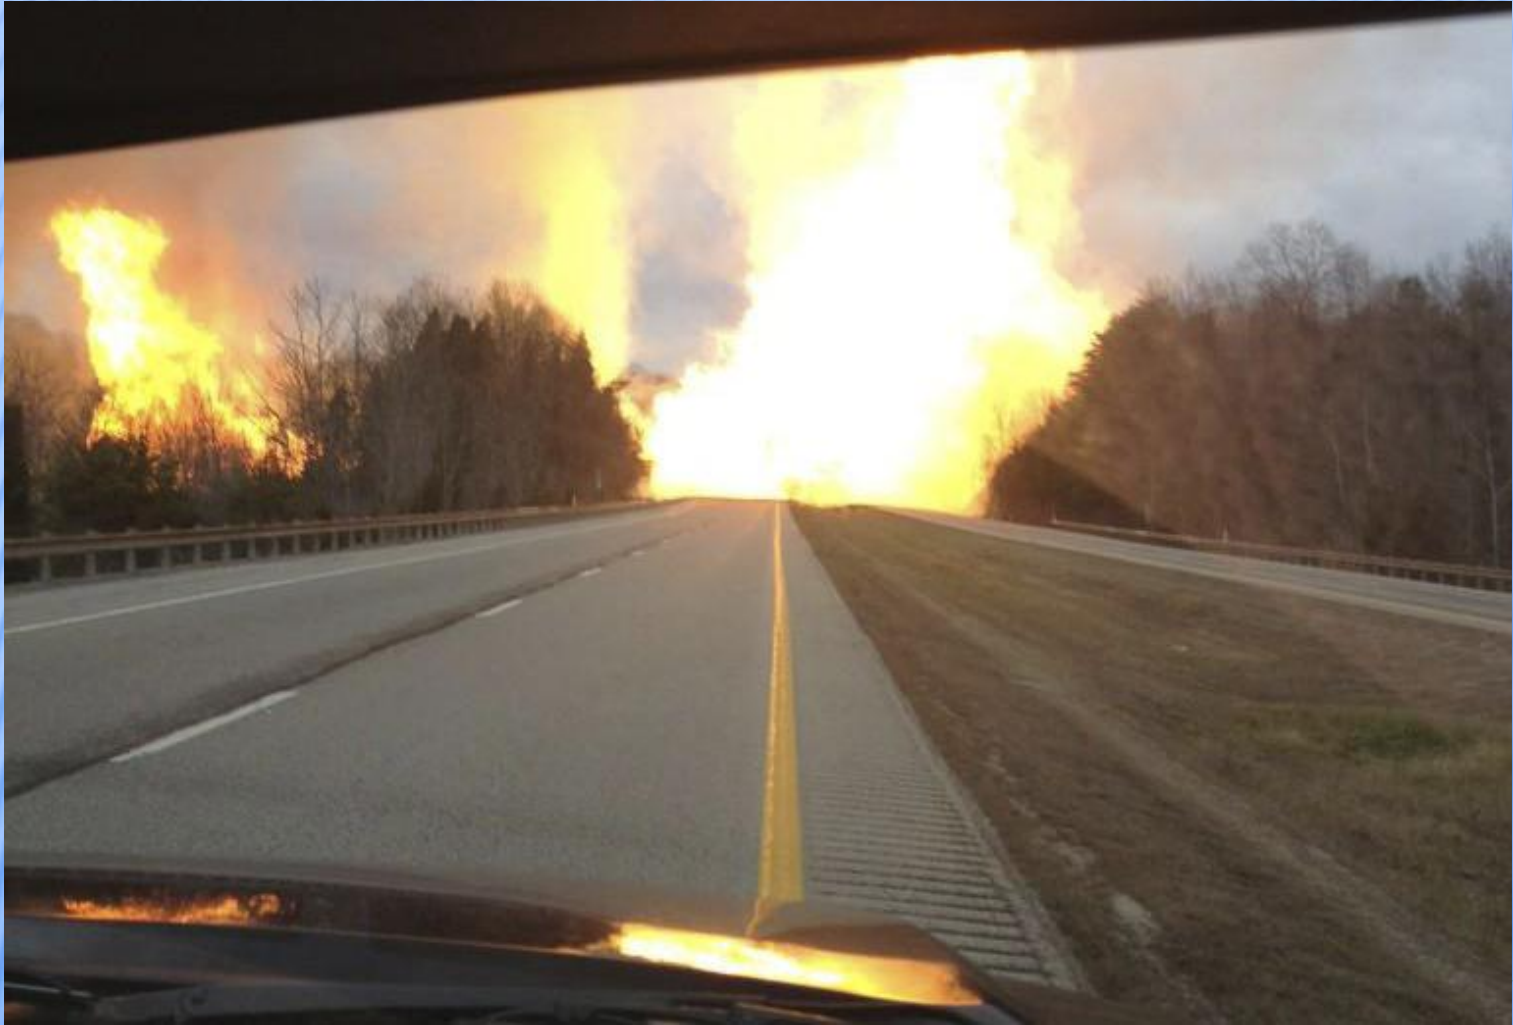
The pipeline operating pressure at the time of the rupture was about 929 psig. Fire damage extended nearly 1,100 ft. along the pipeline and about 820 ft. wide.

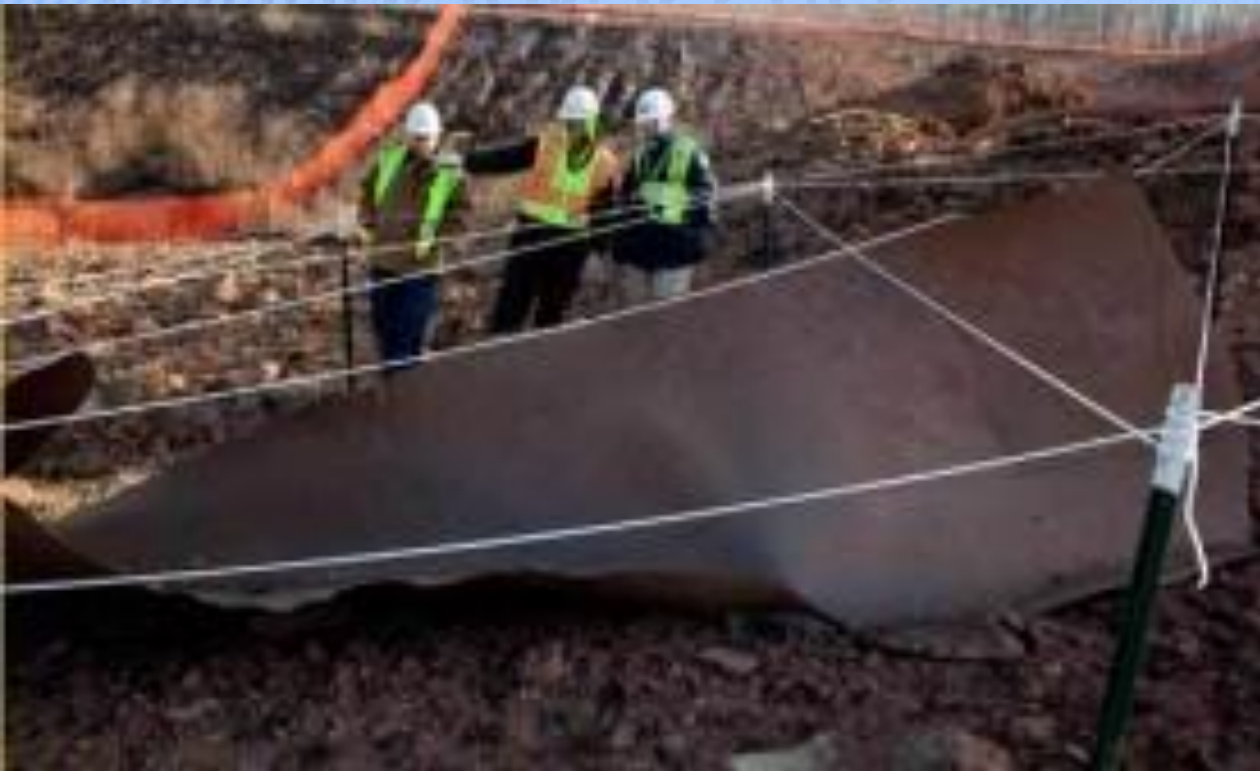
About 20 feet of pipe was ejected from the pipeline and landed more than 40 feet from its original location.

The outside surface of the pipe was heavily corroded. The wall thickness had degraded so significantly that it measured about 70% thinner than the original wall thickness.

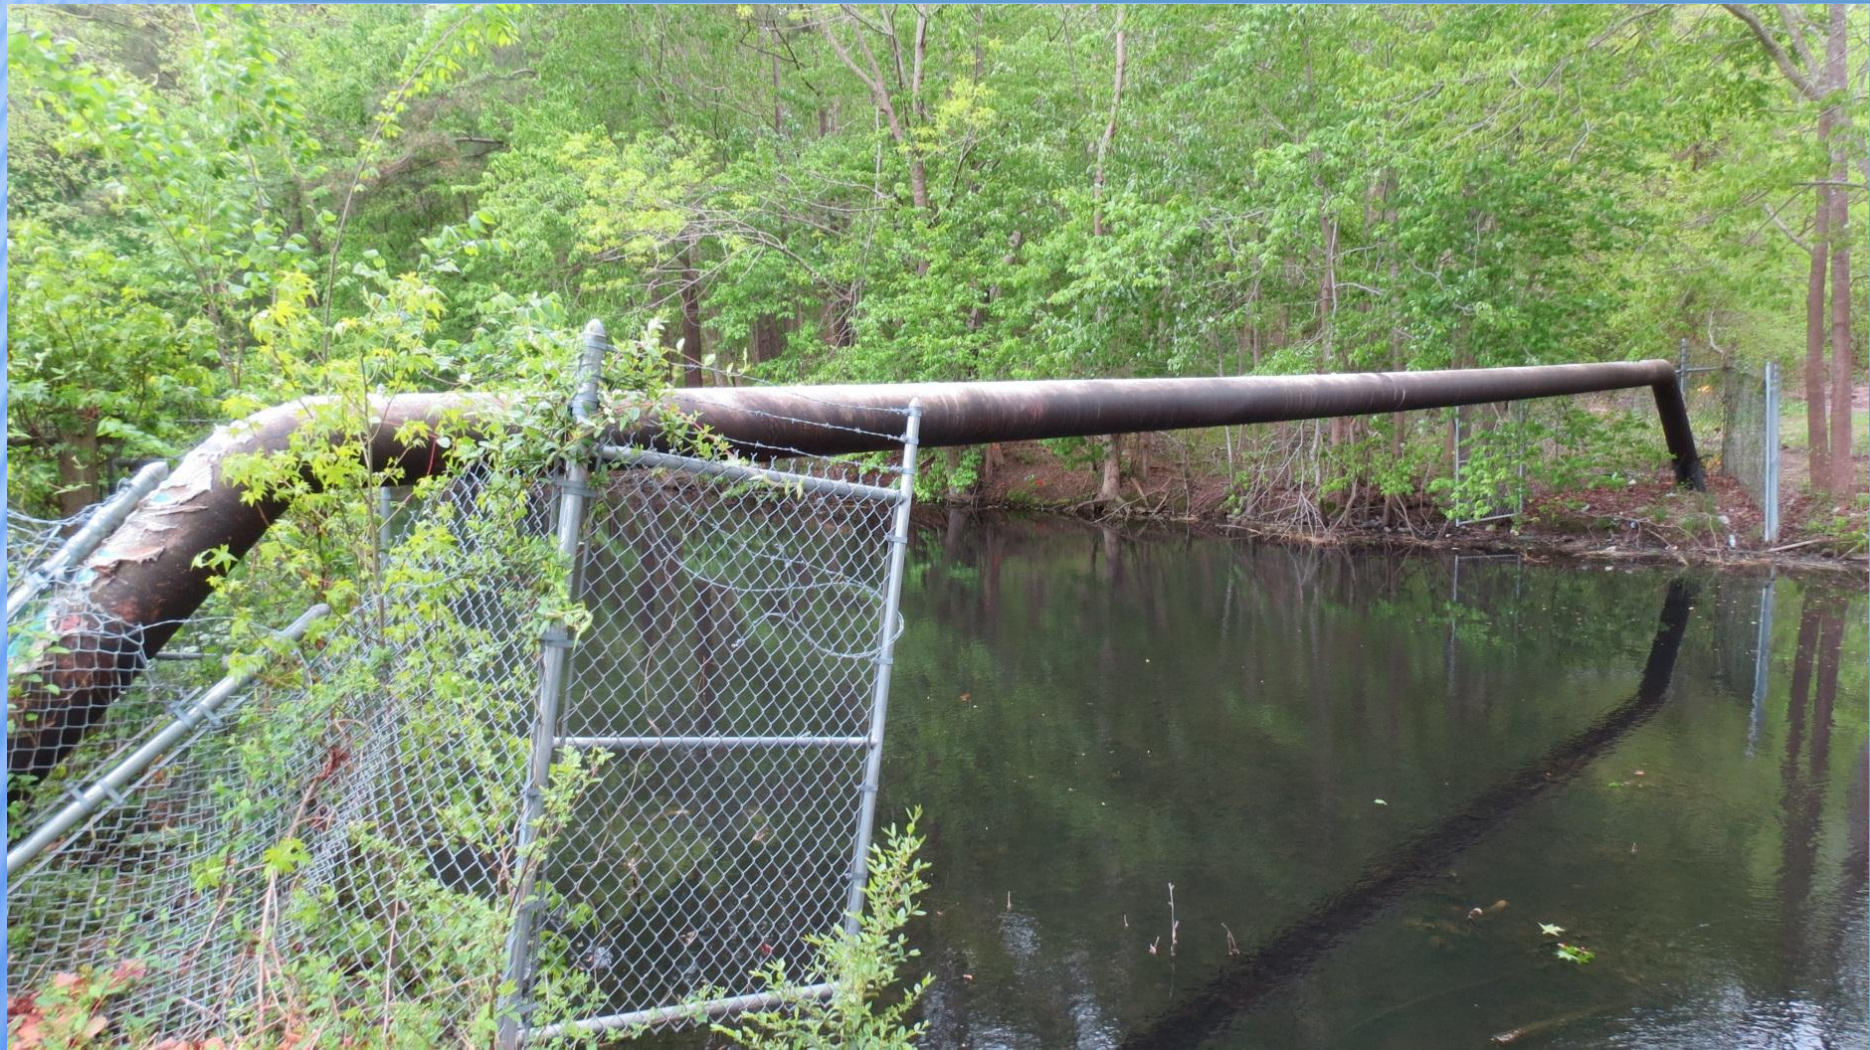
**Installed in 1994, No atmospheric corrosion inspections conducted on this exposure.**

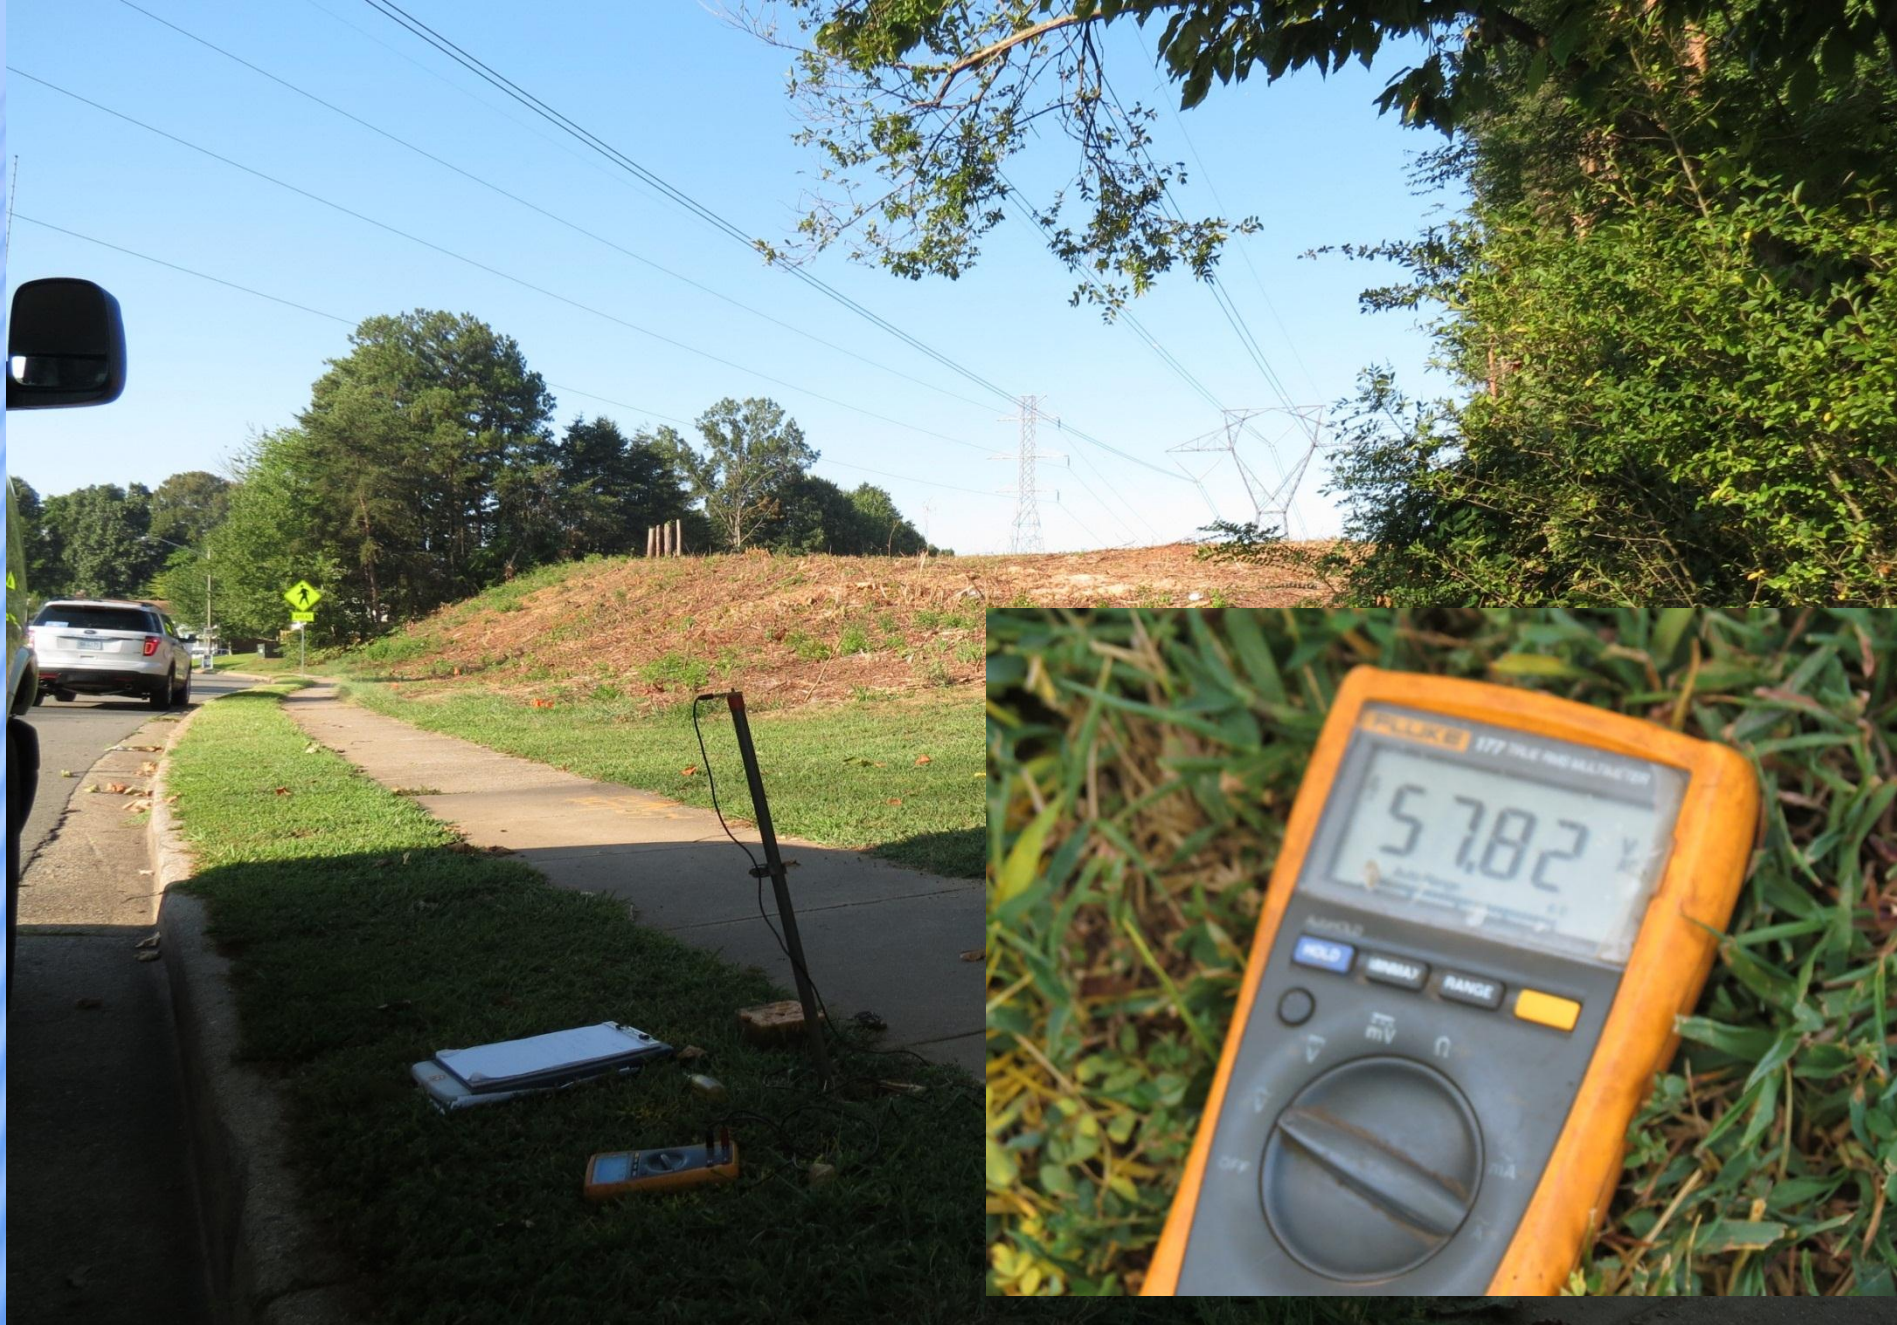
AC interference on a gas main

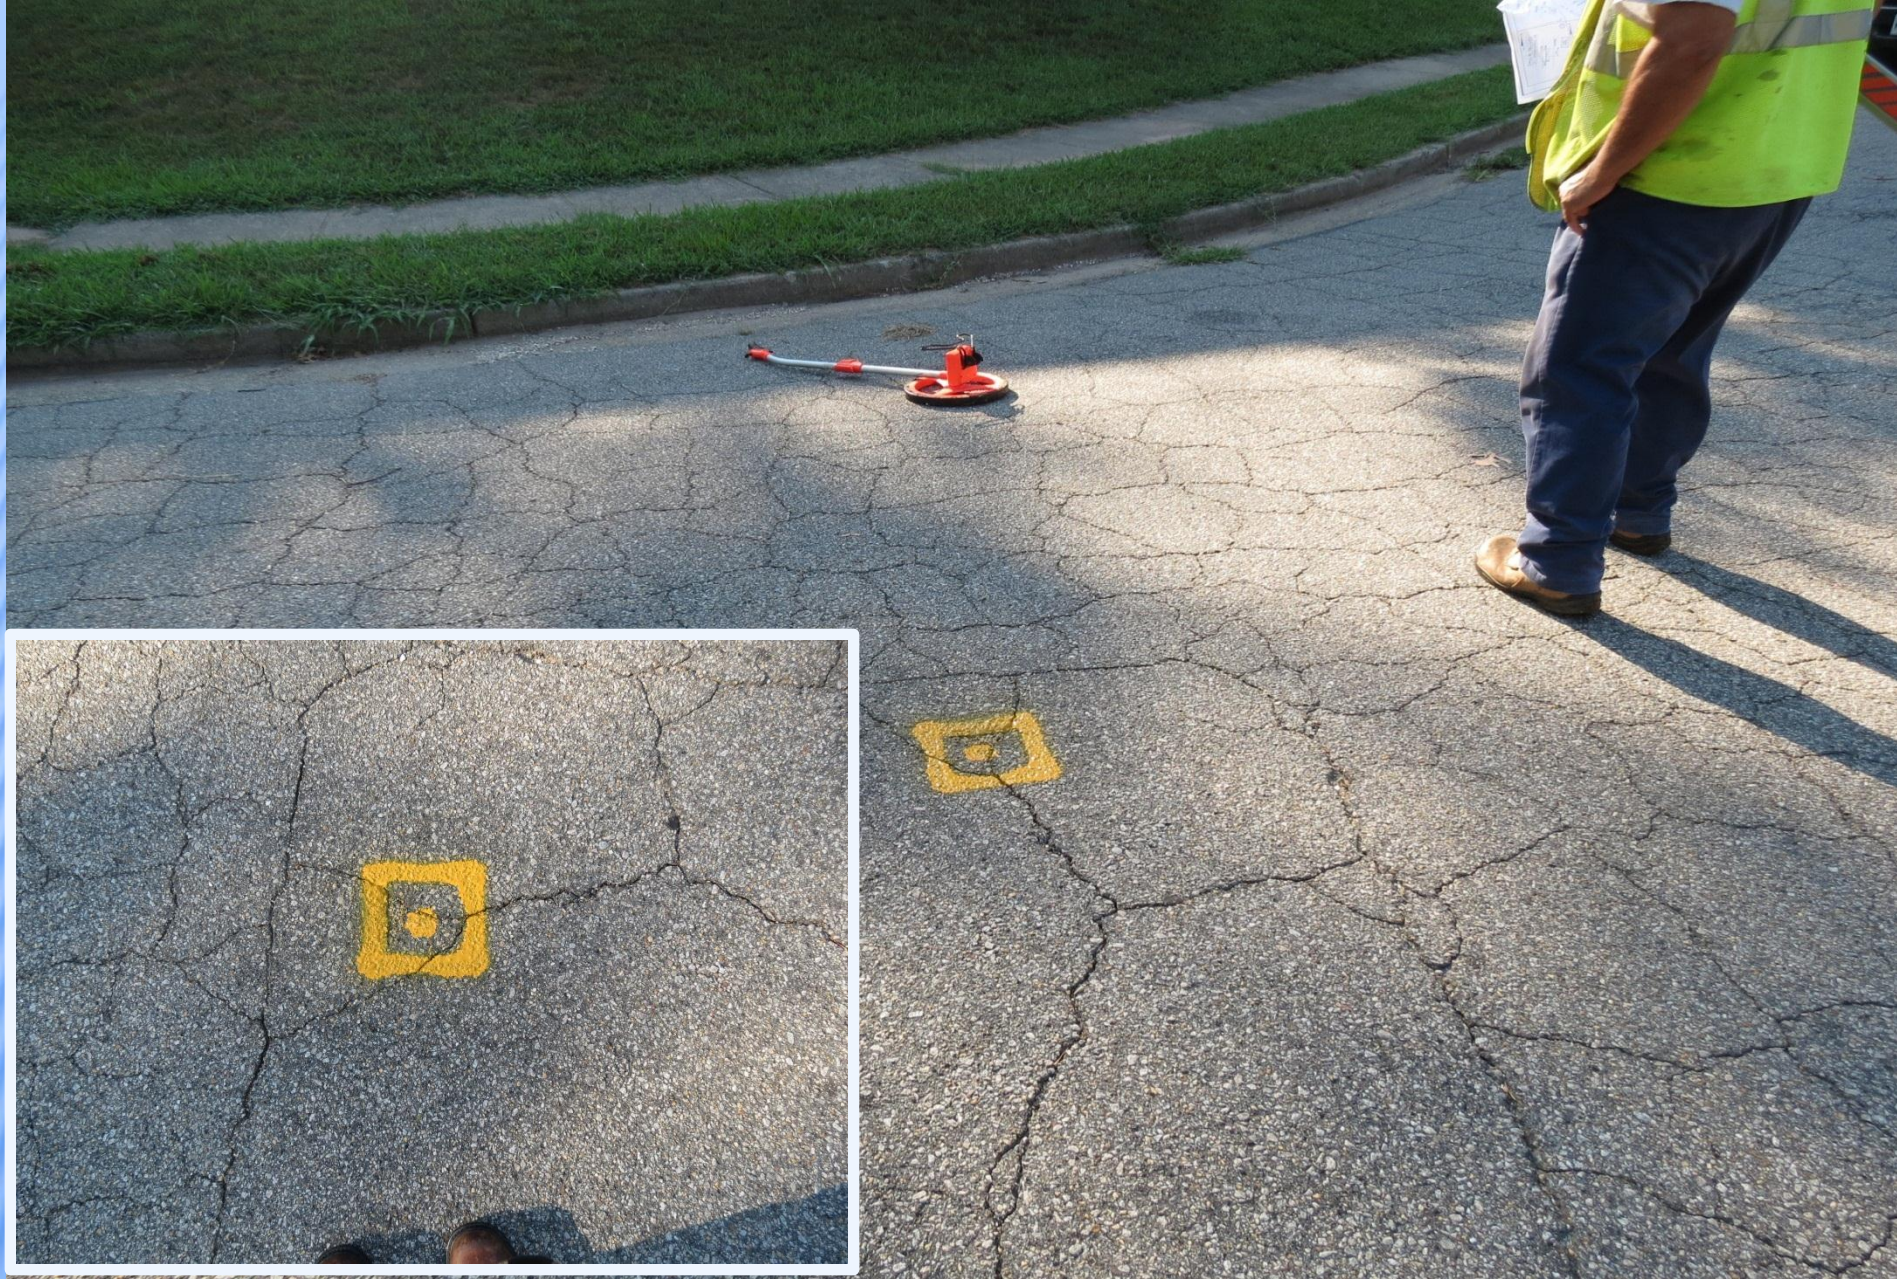
Test stations paved over

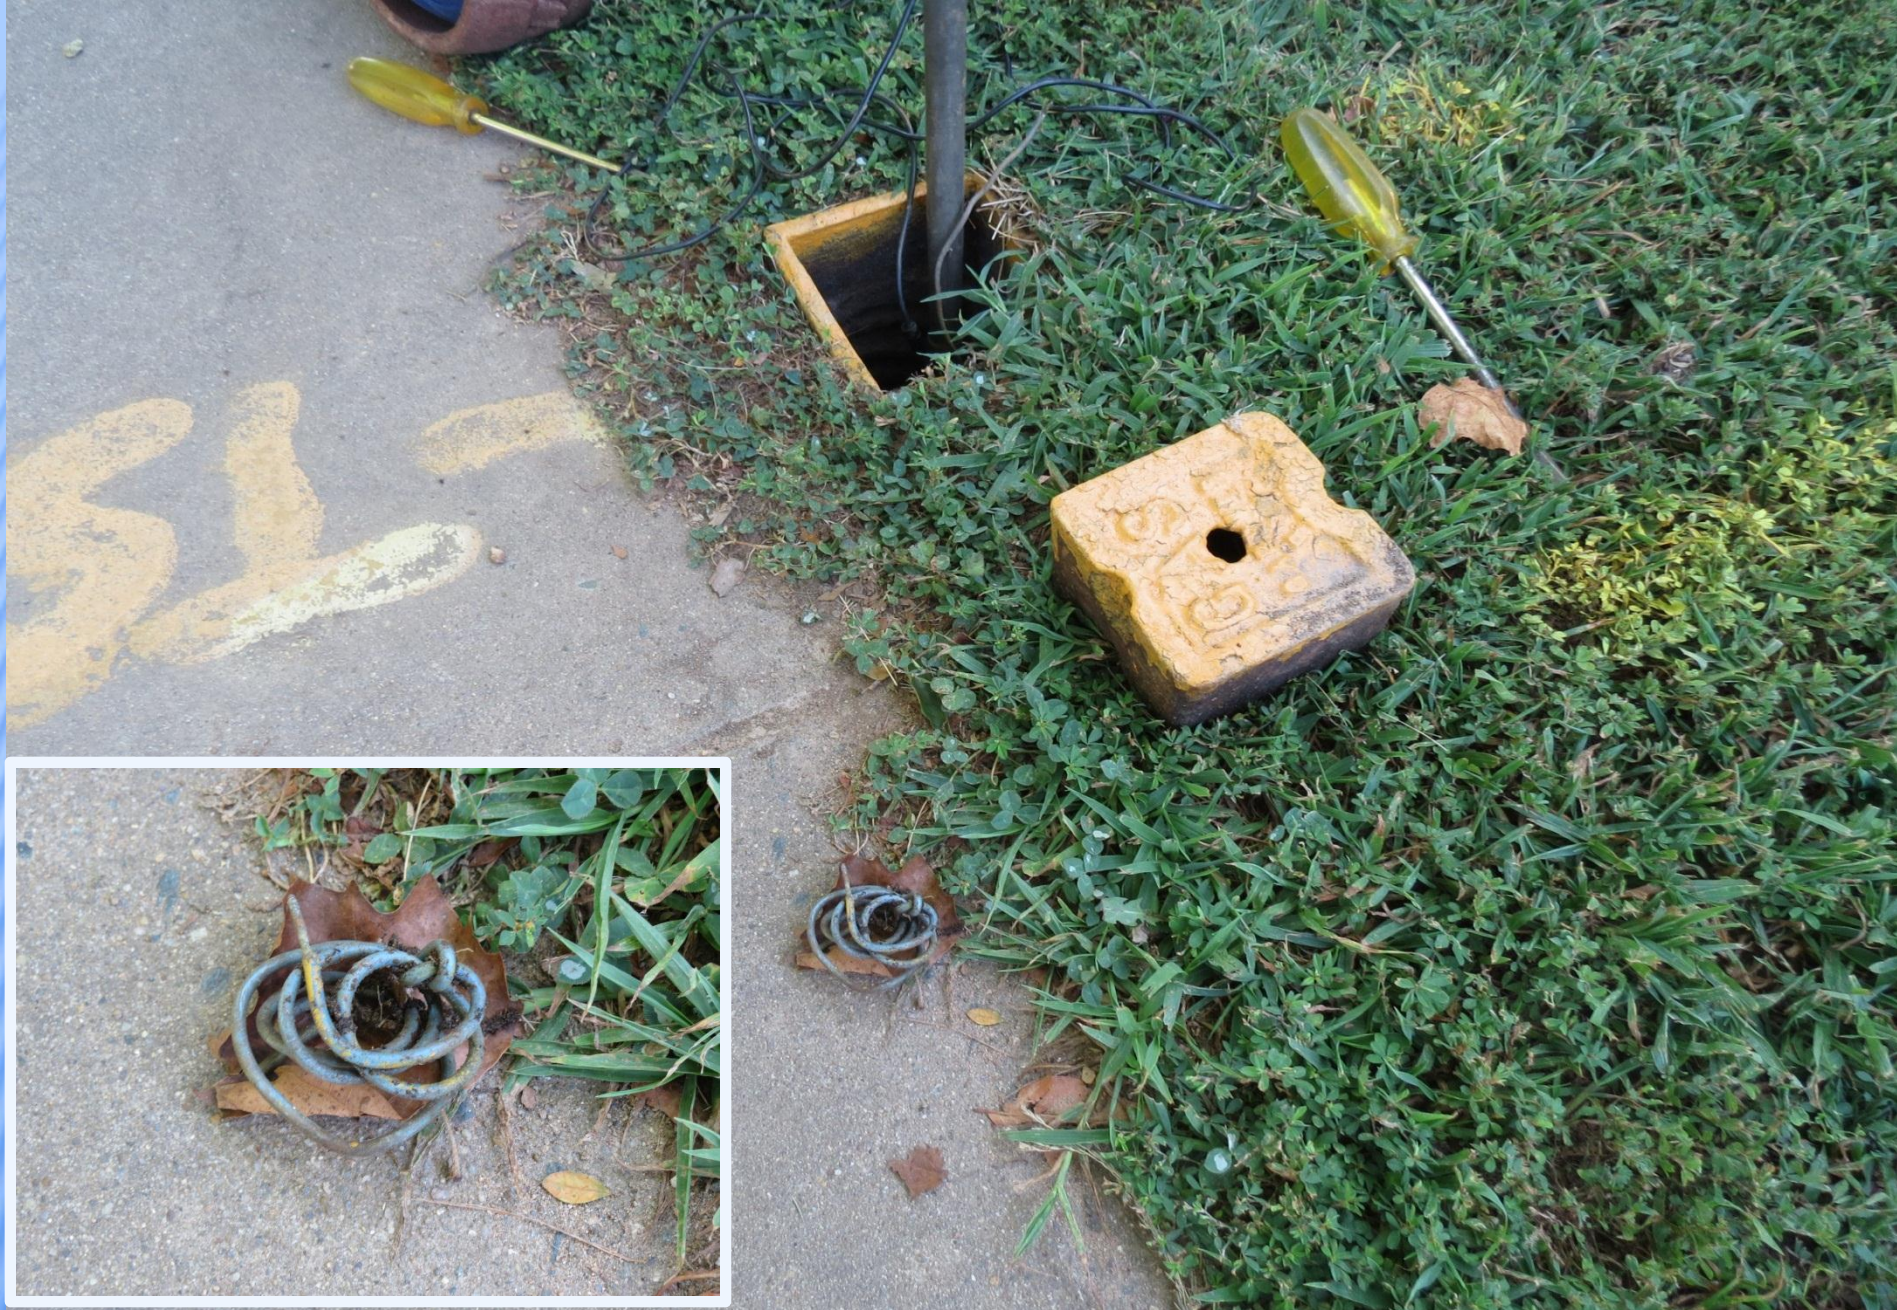
Missing / broken test station leads

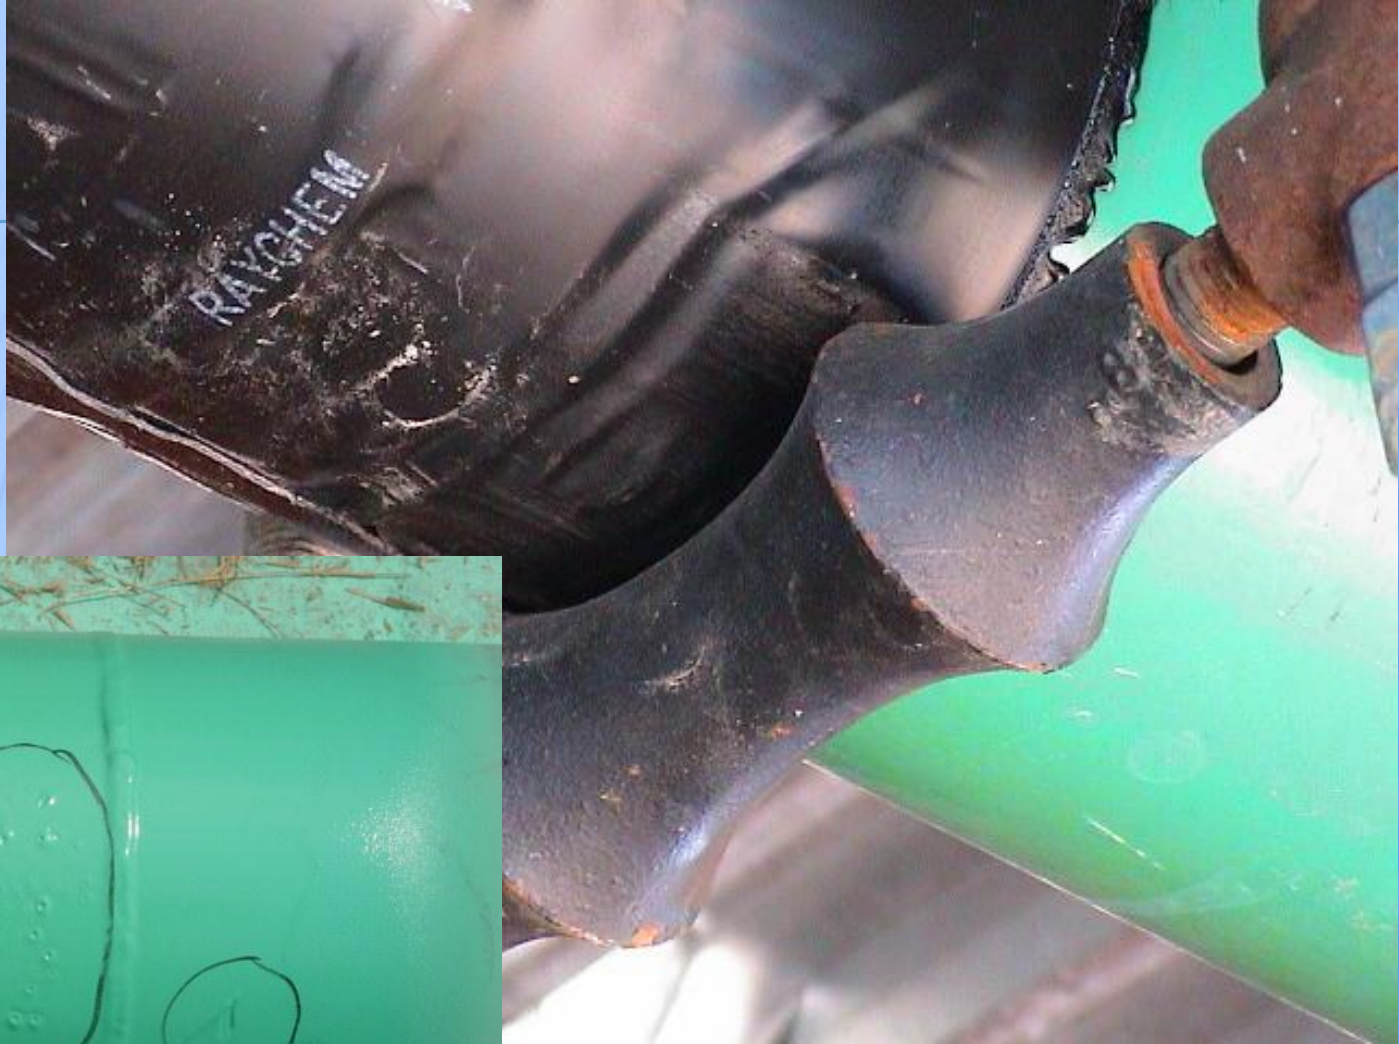
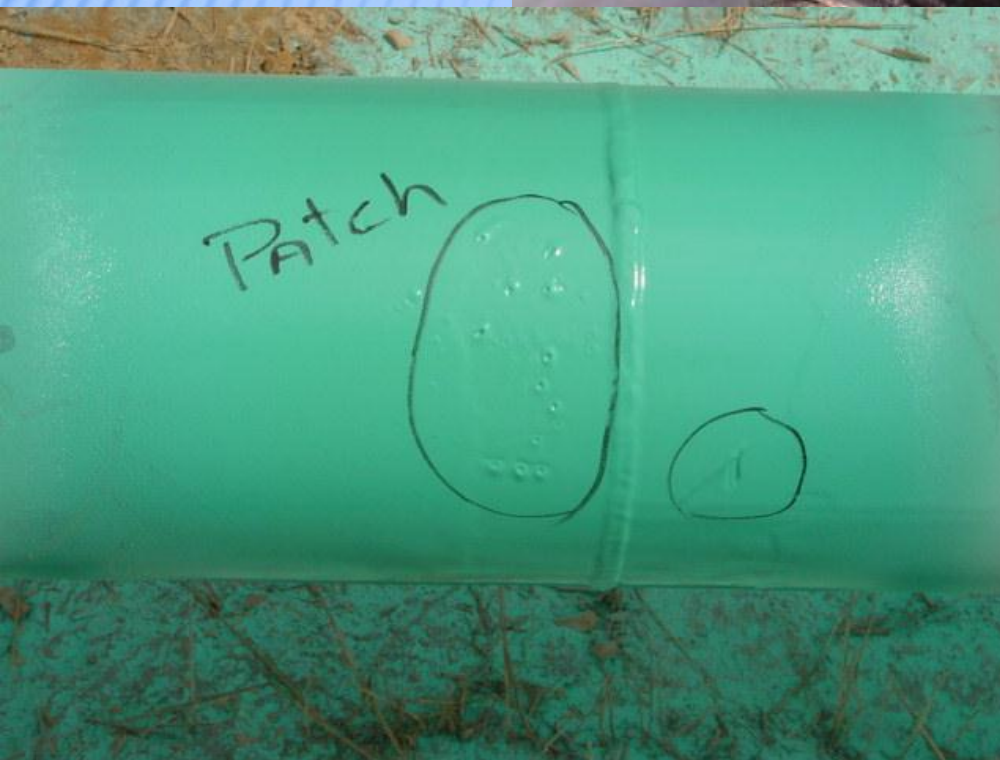
**Bad coating issues**

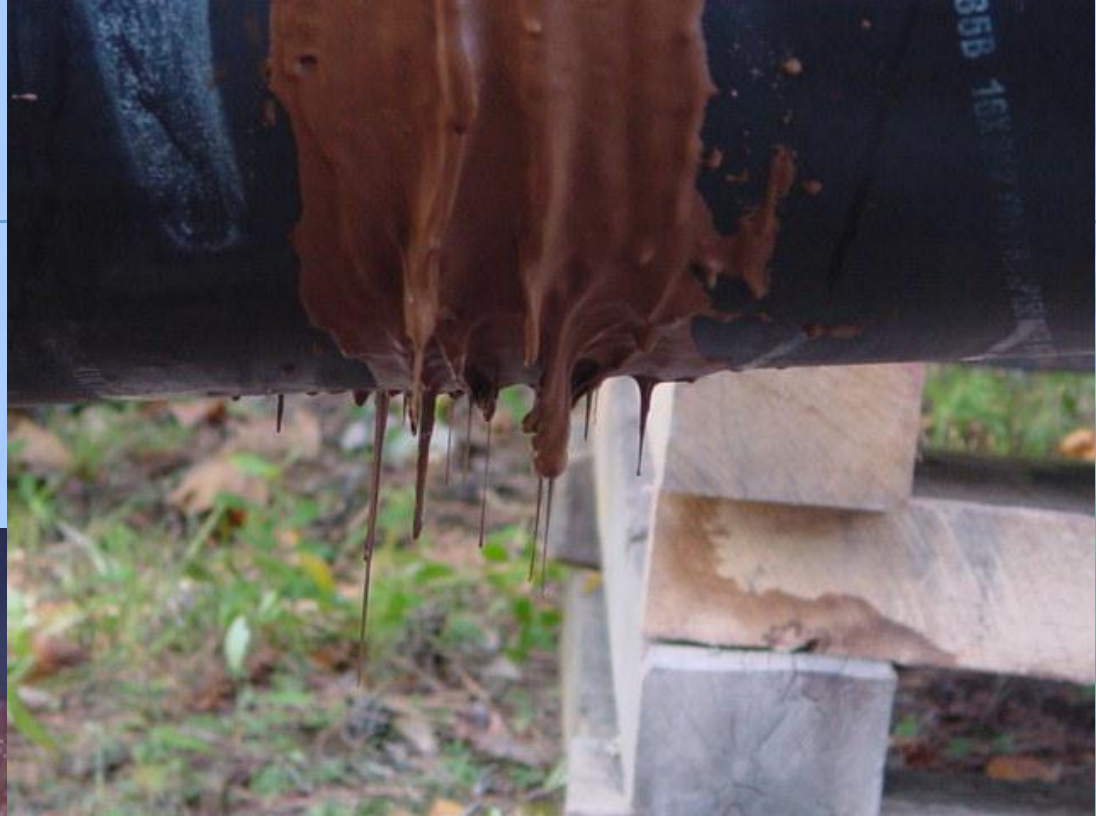
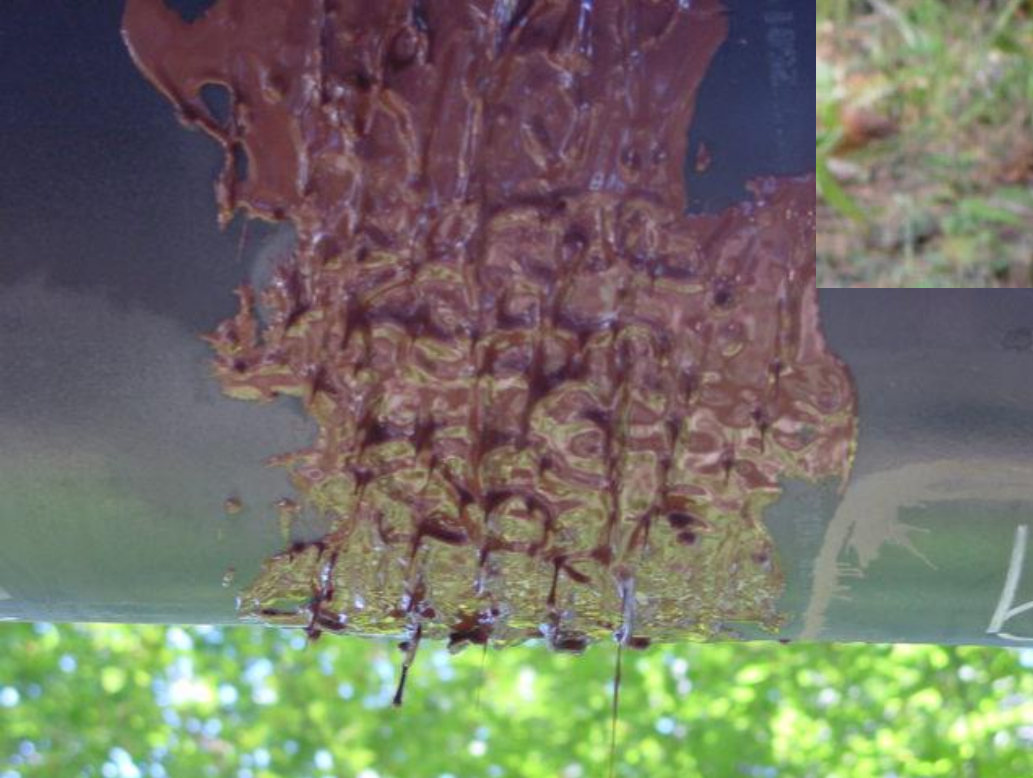
**Bad coating issues**

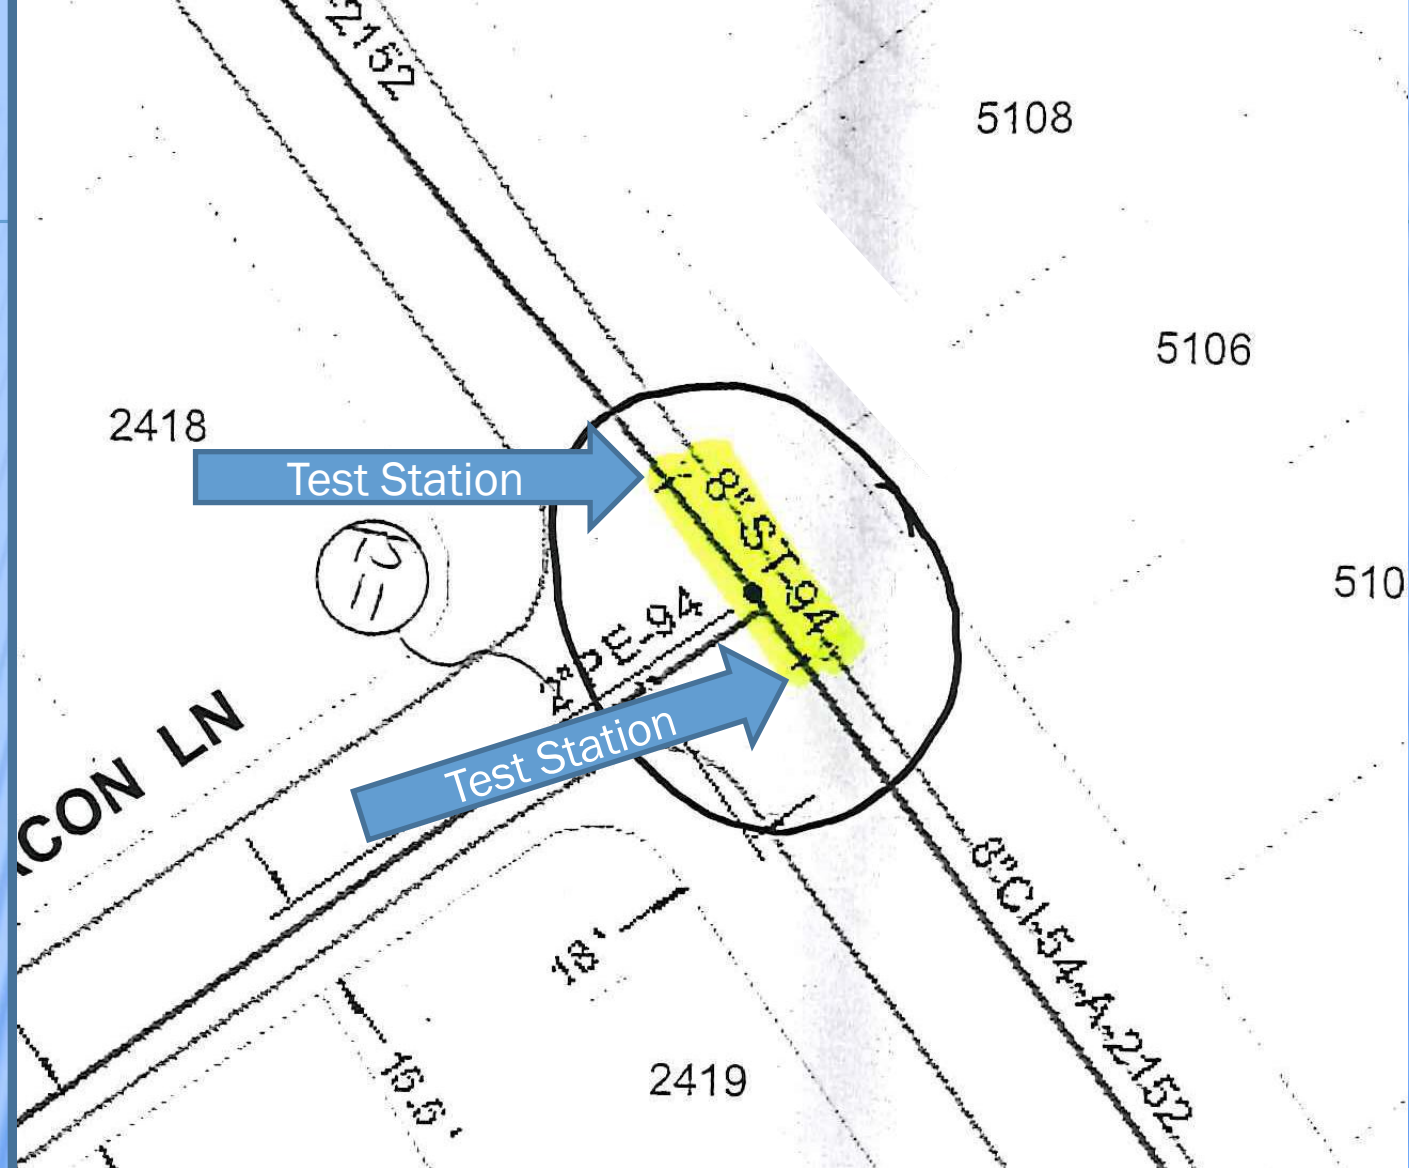
Main installed in 1994 with 2 test stations, test stations not monitored

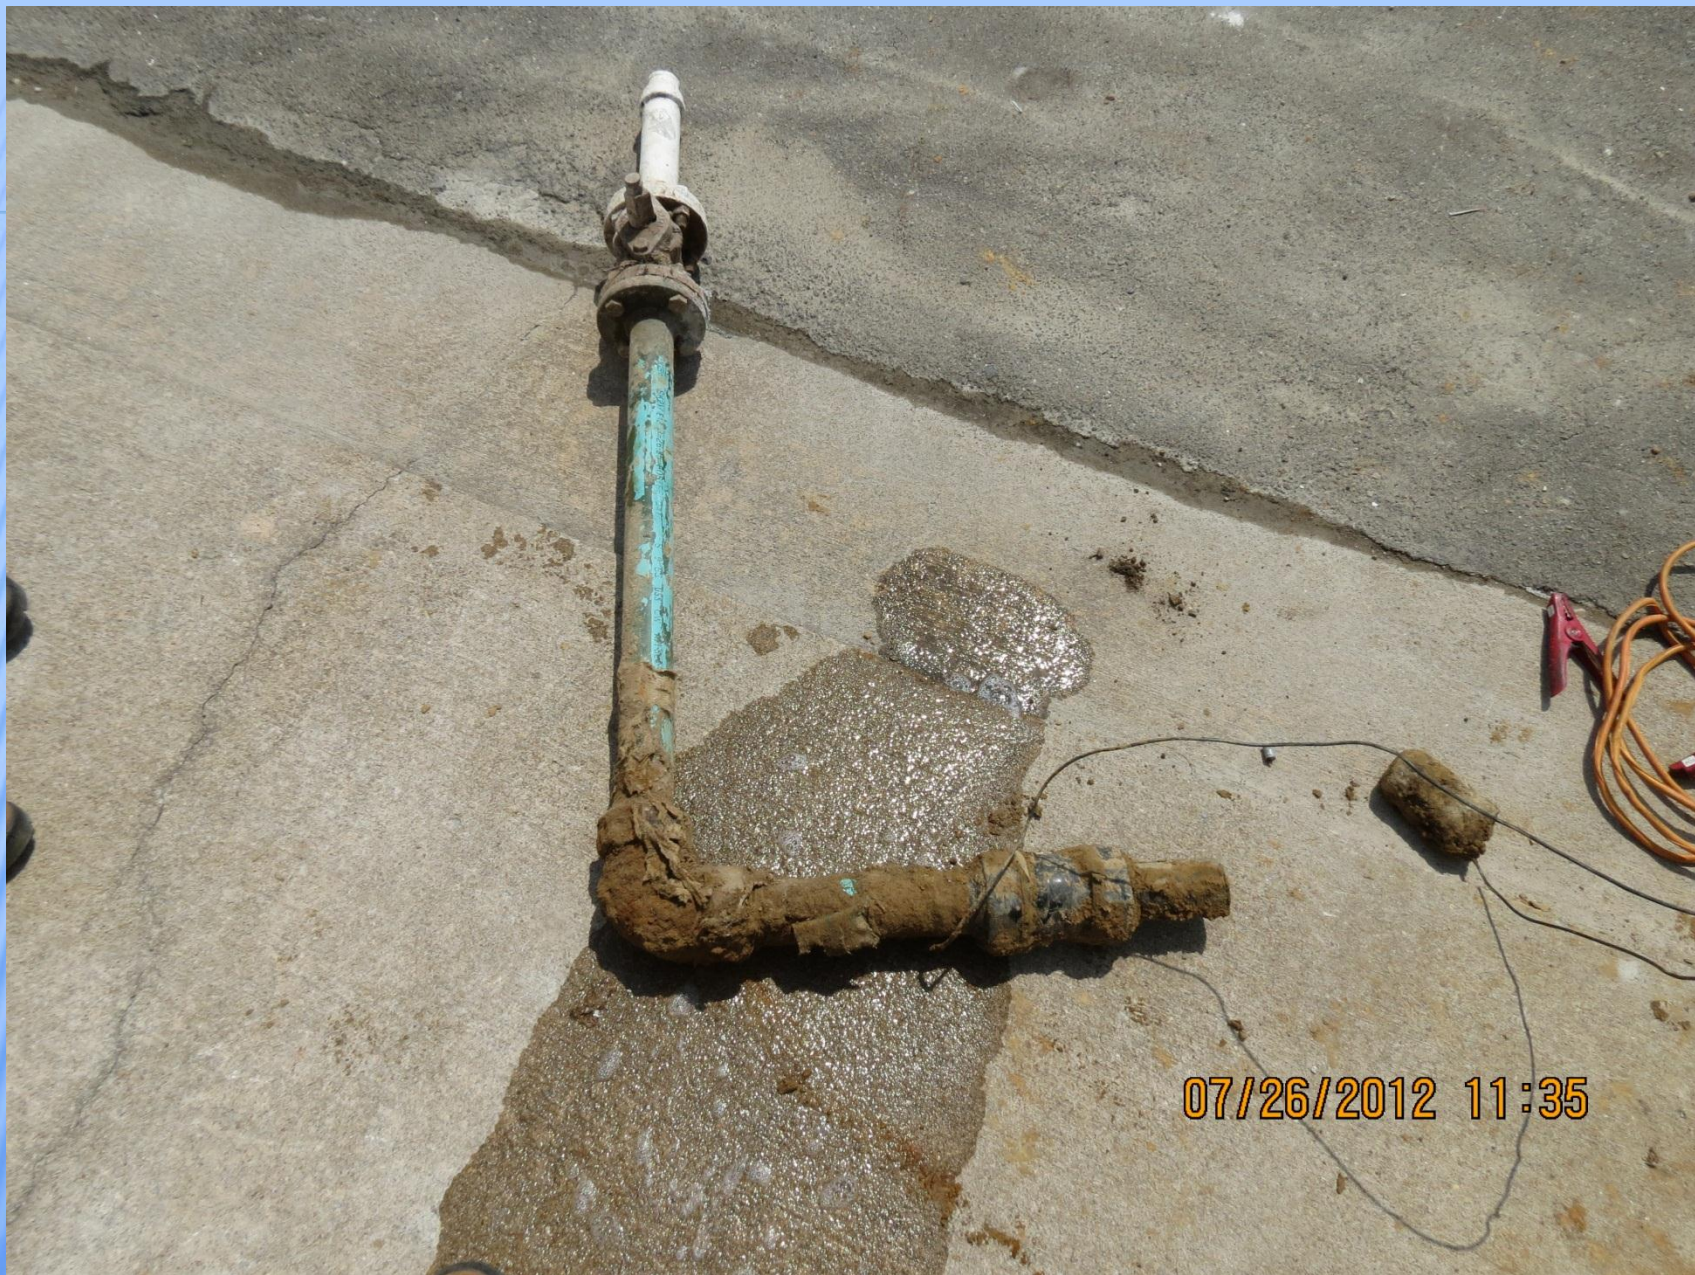
**Isolated risers - Not monitored for CP**

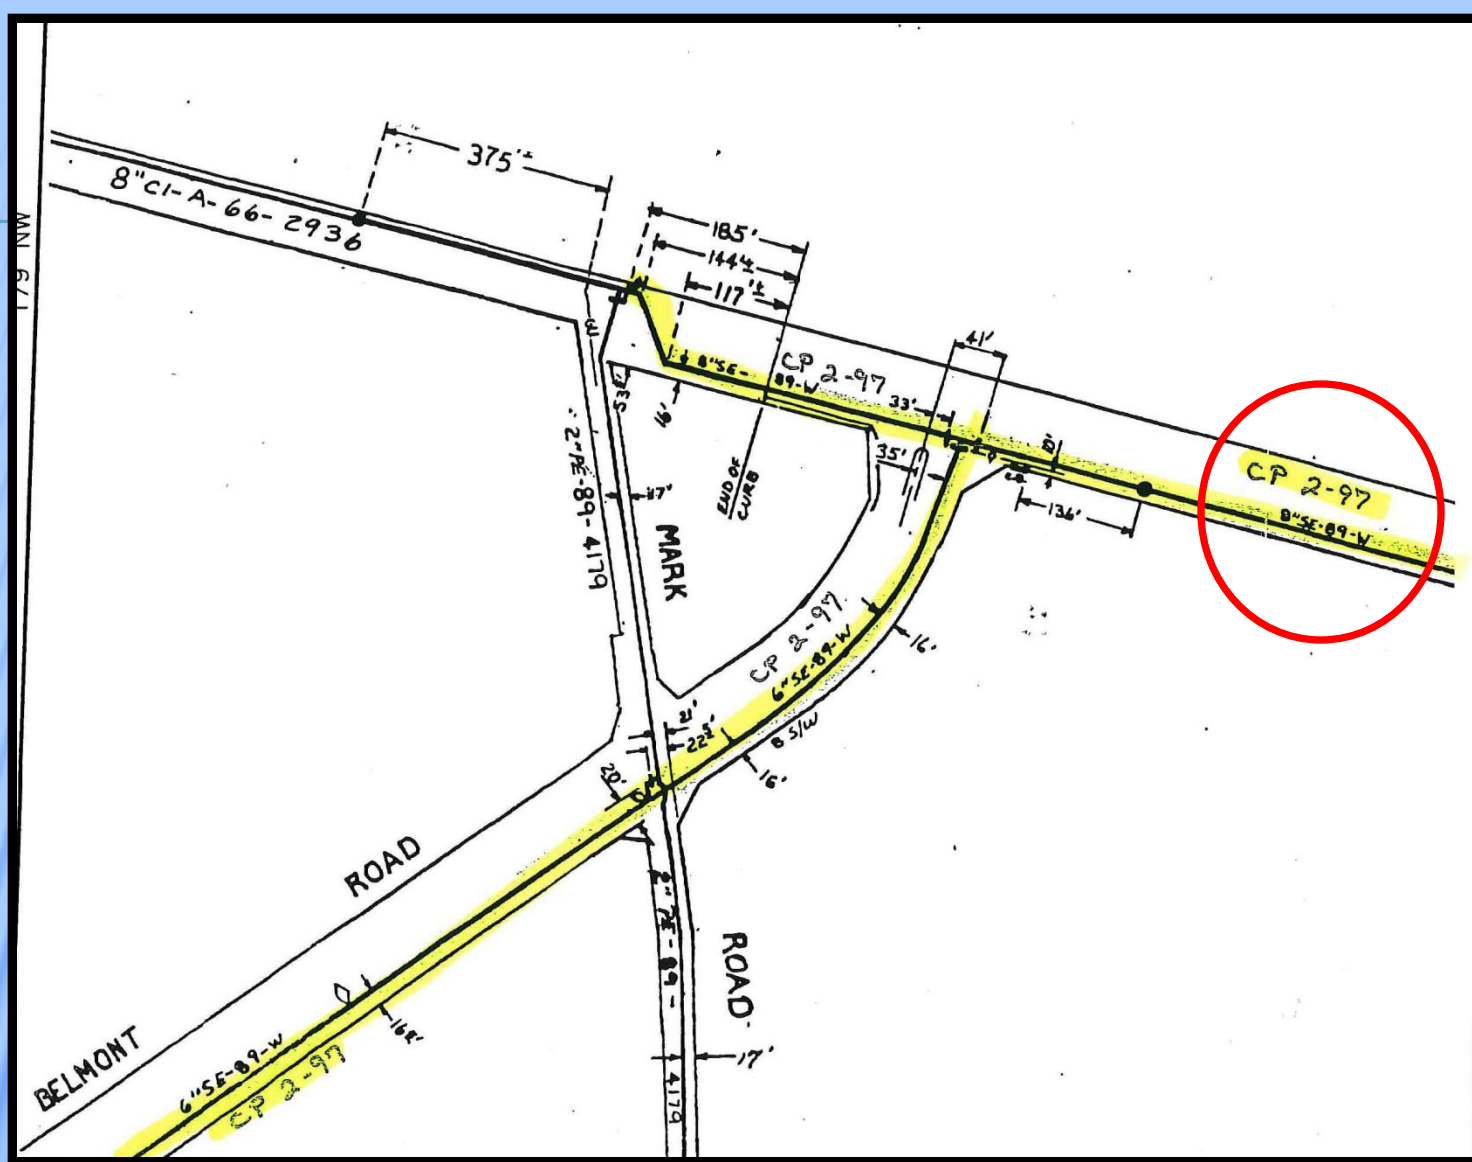
Mains installed in 1989, not placed under cathodic protection until 1997
